## Technical Evaluation of the Gold King Mine Incident

San Juan County, Colorado

U.S. Department of the Interior  
Bureau of Reclamation  
Technical Service Center  
Denver, Colorado

October 2015

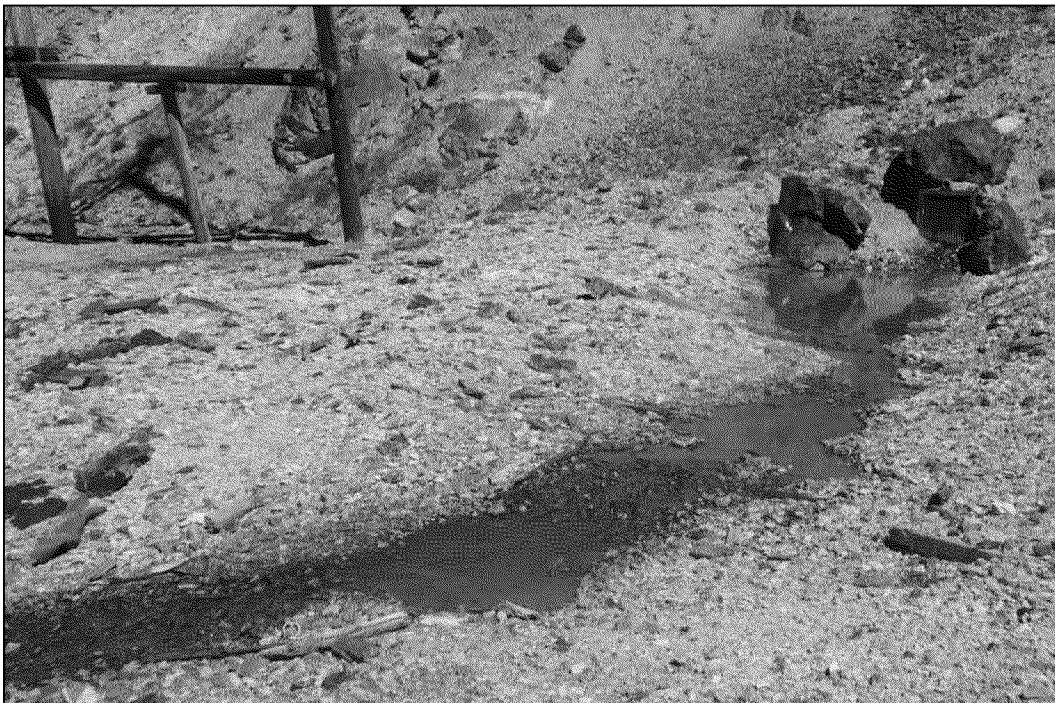
Figure 31.—Gold King Mine Level 7 OLD Adit (upper right) showing a small amount of seepage flow on September 11, 2014. At the portal, the floor of the old adit is approximately 2 feet higher than the floor of the old adit portal (photograph from EPA project files).

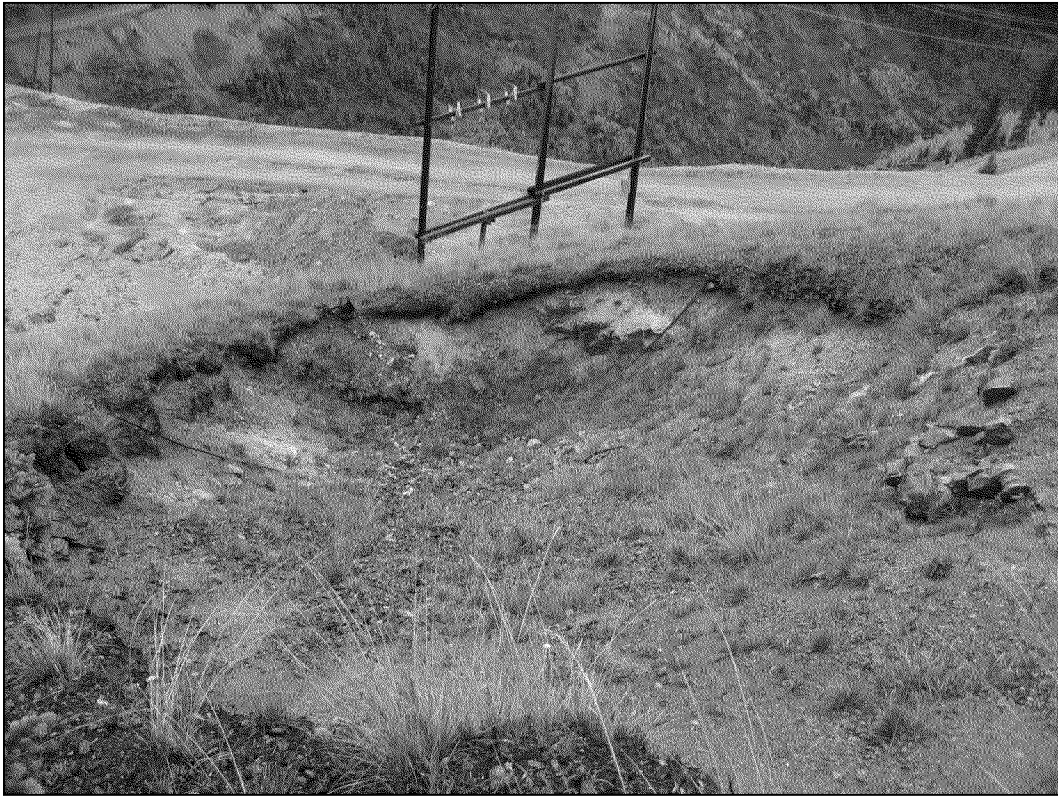
Figure 32.—Photograph taken on September 22, 2014, looking downhill at the subsidence pit located above the Gold King Mine Level 7 Old Adit.

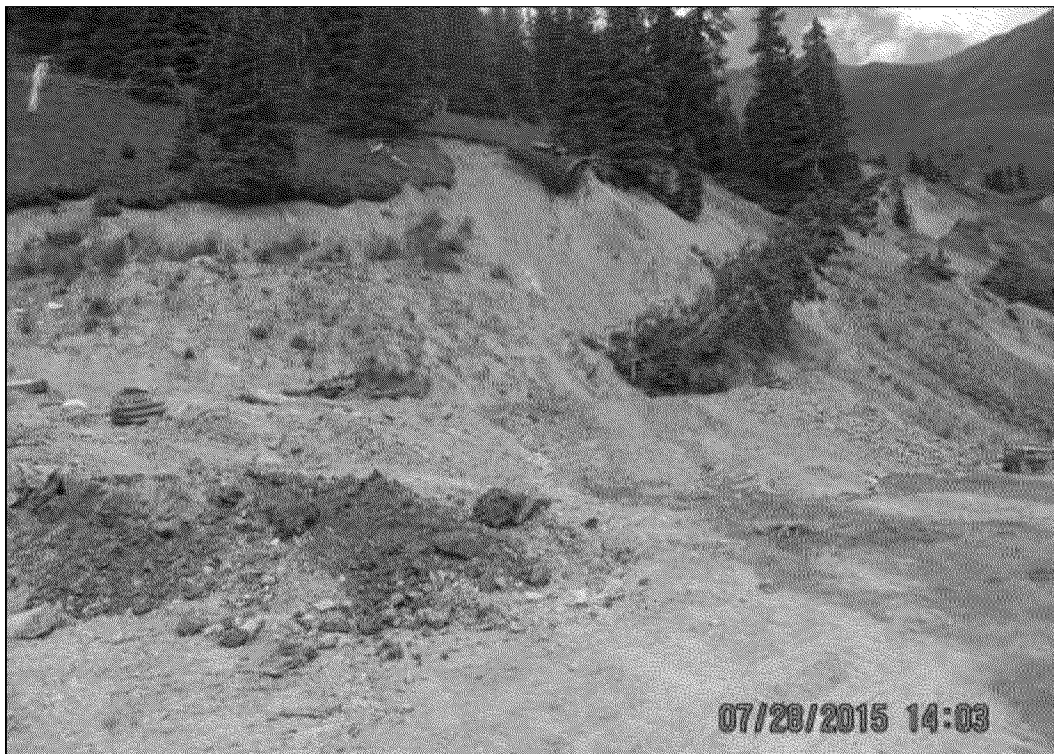
Figure 35.—Photograph showing the condition of the Gold King Mine Level 7 New Adit portal area on July 28, 2015. Note the soil and a tree that has slid downslope onto the portal area; at this time the seepage had been returned to the concrete trough, and the dump was drying out (photograph from EPA project files).
